FOI number: **HBC\_FOI\_20190774**  
Date FOI Received: **03/11/2019**  
Department: **Parks**  
Title: **Trees and TPOs in Ely Gardens, Borehamwood**  
Description: **Details of reports on oak trees in Ely Gardens and Tree Preservation Orders in place across Hertsmere.**

# Arboricultural Appraisal Report

Subsidence Damage Investigation at:

## Initial Technical Report

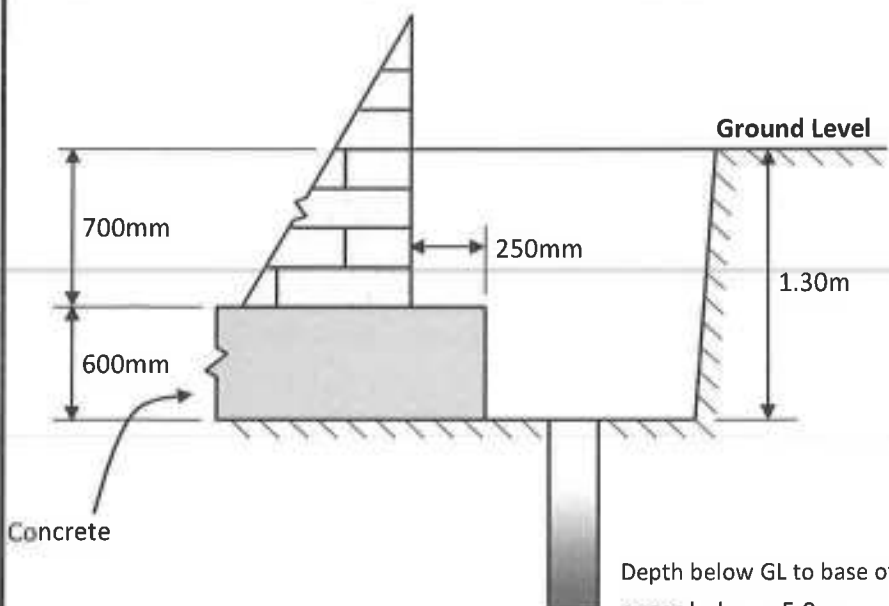
Down to 3.5m  
up to 1mm diameter
