FOI number: **HBC\_FOI\_20190774**  
Date FOI Received: **03/11/2019**  
Department: **Parks**  
Title: **Trees and TPOs in Ely Gardens, Borehamwood**  
Description: **Details of reports on oak trees in Ely Gardens and Tree Preservation Orders in place across Hertsmere.**

# Arboricultural Appraisal Report

Subsidence Damage Investigation at:

## Initial Technical Report

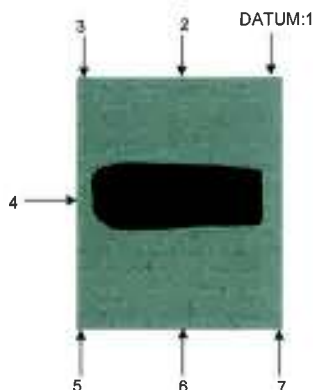
REAR

FRONT

07/02/2018

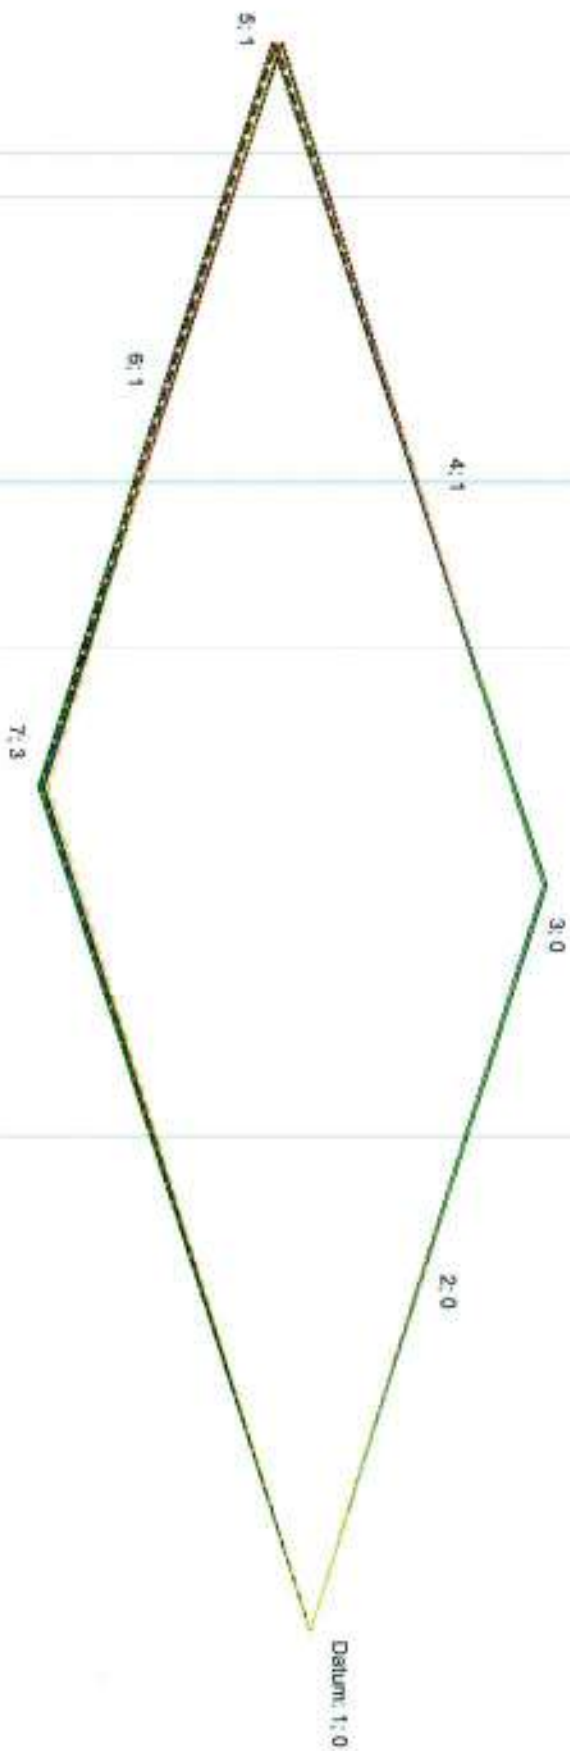
Reading 2 (15/12/16)	Reading 3 (19/1/17)	Reading 4 (18/2/17)	Reading 5 (22/3/17)
Reading 6 (24/4/17)	Reading 7 (26/5/17)	Reading 8 (18/7/17)	Reading 9 (16/10/17)
Reading 11 (12/12/17)	Reading 12 (13/1/18)	Reading 13 (7/2/18)	Reading 10 (15/11/17)
